Sutton-Kennerly & Associates, Inc.
530 Hendersonville Road
Asheville, NC 28803-2826

ASHEVILLE CITY HALL
WATER INTRUSION INVESTIGATION
FINAL REPORT

February 16, 2010

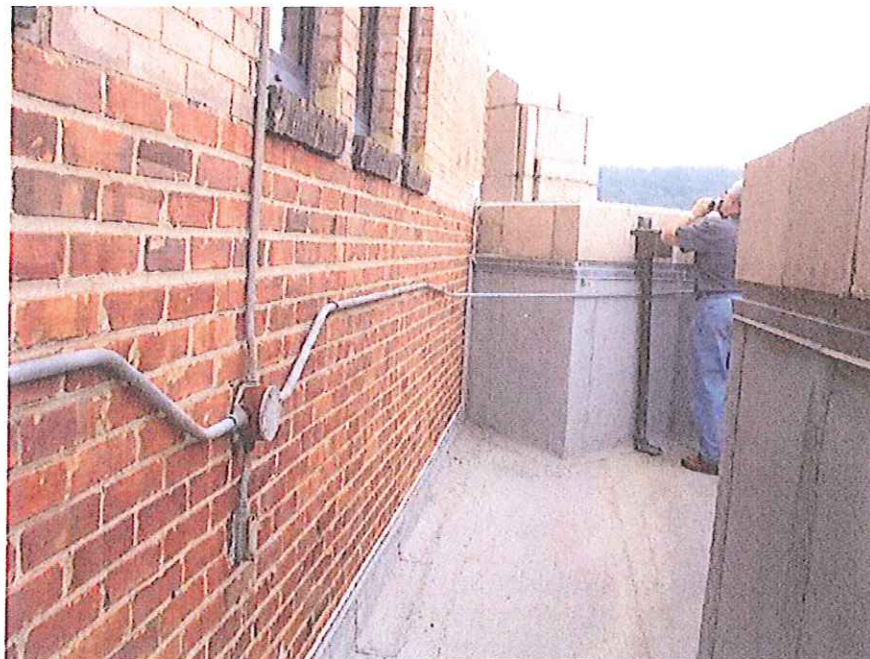
4. A view of the roof at the eighth floor level showing the different brick used at the building wall that is hidden from view. The typical terminations of the roofing membrane are also visible. Note the roofing membrane continuing up the inside face of the parapet.

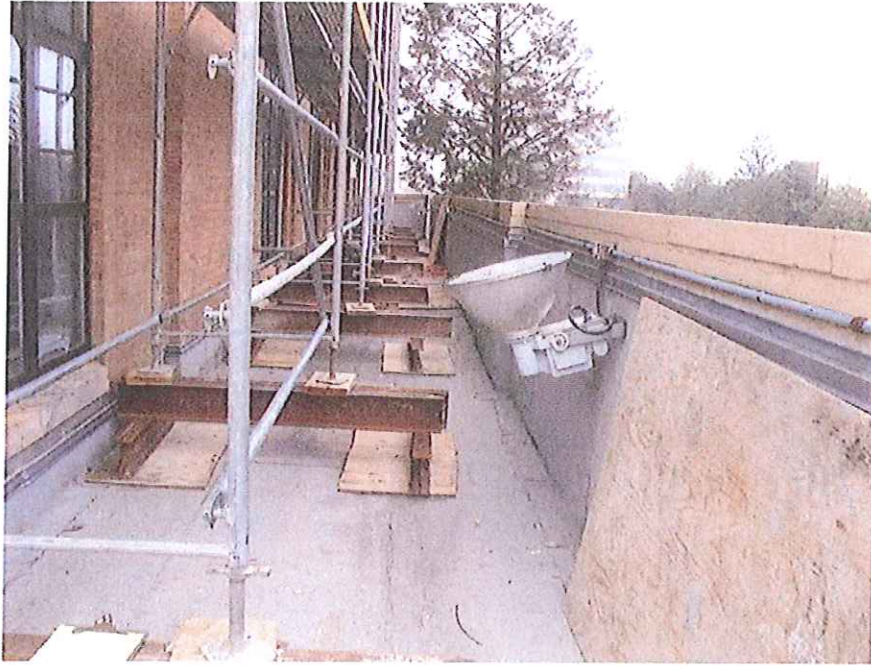
5. A view of the roof at the second floor level on the north side of the building. The roofing at this location also extends up the inside face of the parapet. The marble coping on the parapet is also visible showing and elastomeric coating on the inside face of the coping.

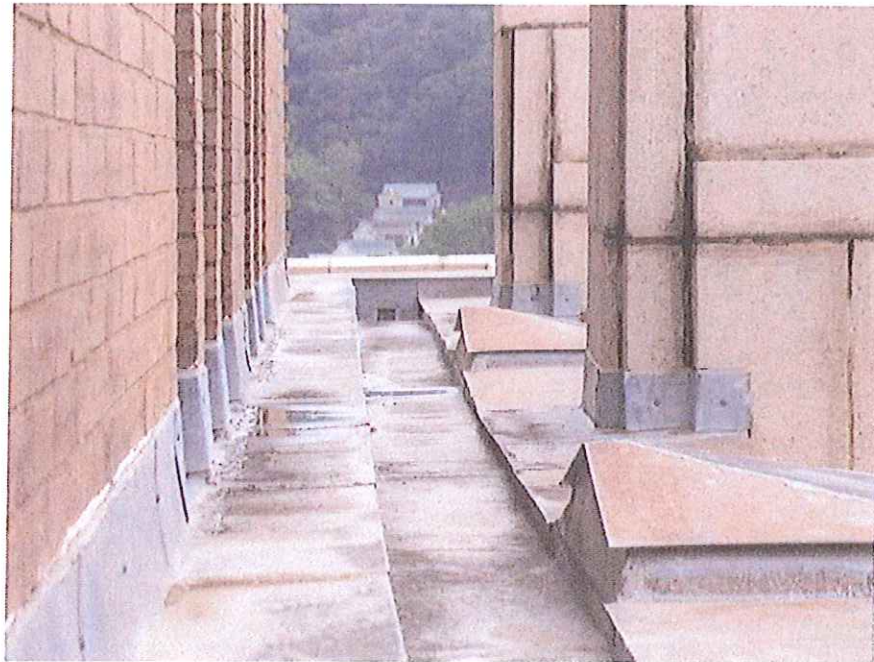
6. A view of the concealed gutter at the eighth floor level. It is believed that the gutter was lined with lead coated copper in the early 1990's.

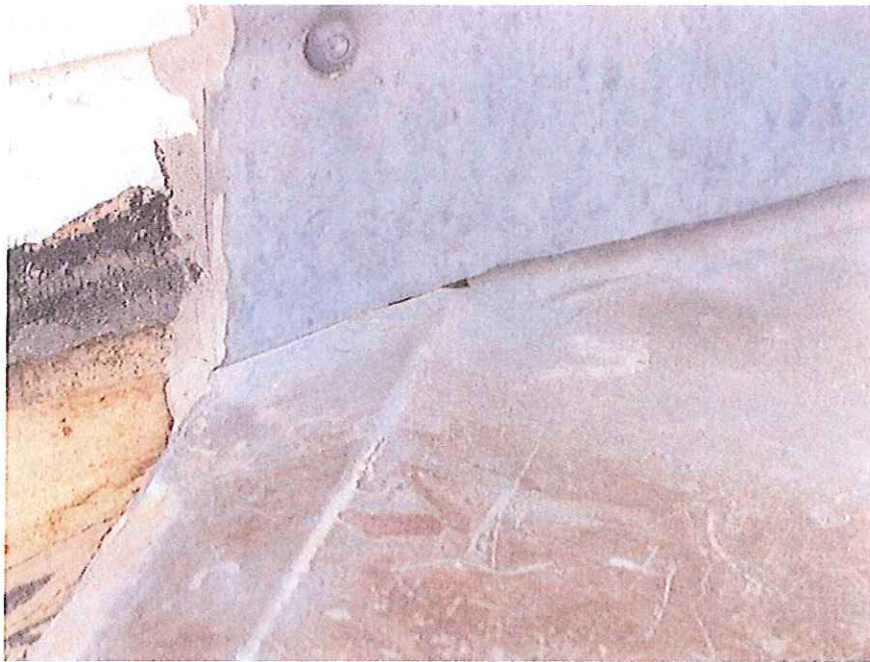
7. A closer view of one of the flashing conditions at the concealed gutter showing a void area that can allow water to enter the building.

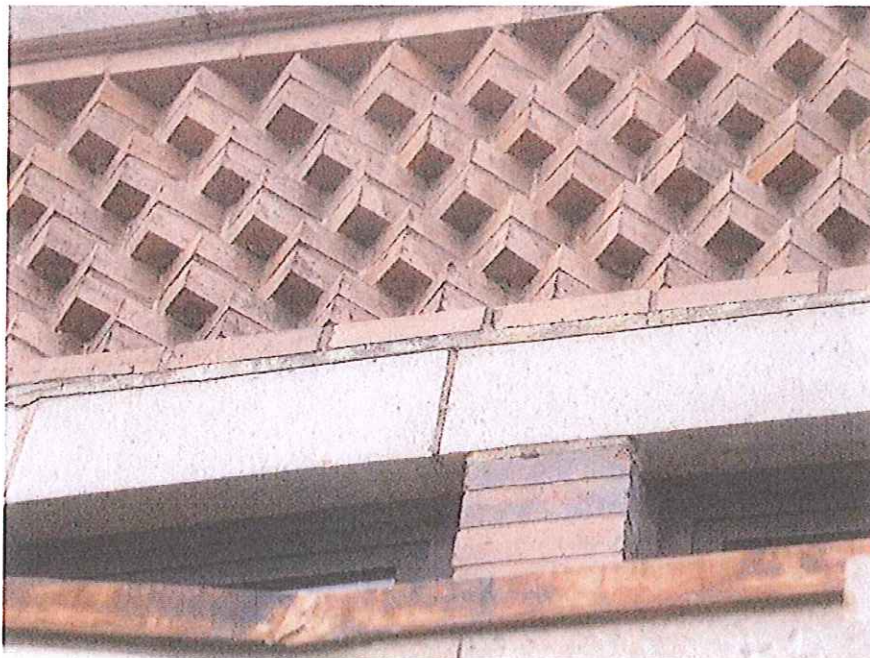
8. A view of the decorative brick work and terra cotta just below the octagonal roof. Note the corrosion on the flashing at the lower wall.

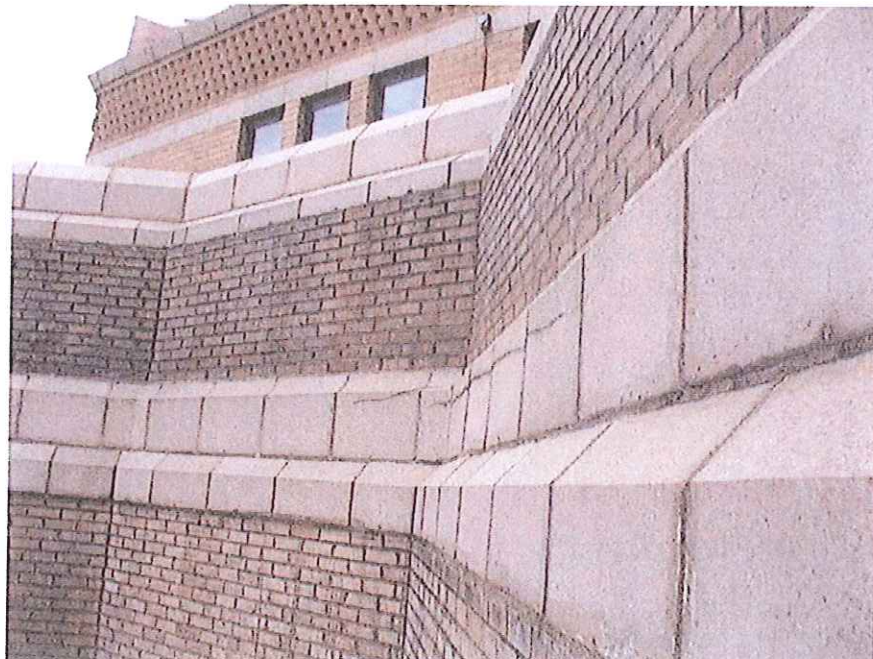
10. A closer view of the brick and terra cotta. Some of the damaged terra cotta is visible as well as the remains of a black surface applied sealant that was previously installed over the mortar joints in the brick and the terra cotta.

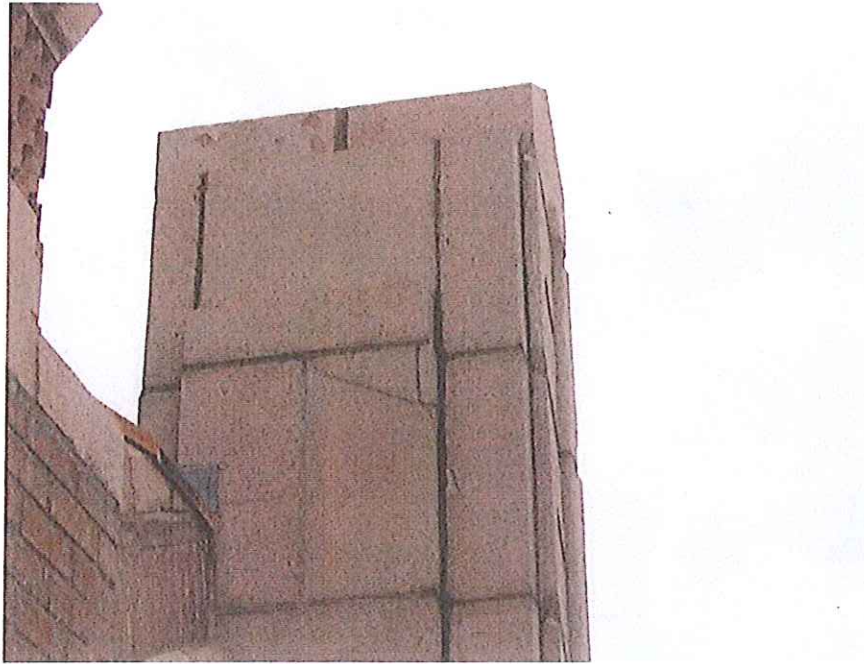
11. A view of one of the terra cotta piers just above the eighth floor showing cracks in the terra cotta and some spalling of the glaze on the terra cotta.

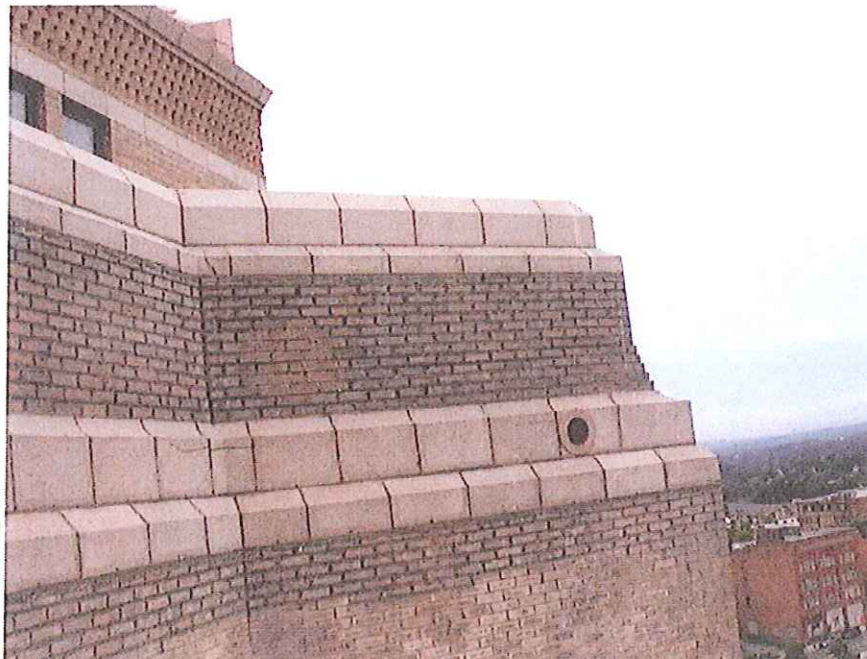
12. Another view of the general configuration of the brick and terra cotta at the eighth floor level. The same typical conditions are present on the brick and terra cotta including cracks in the terra cotta and the black surface applied sealant material.

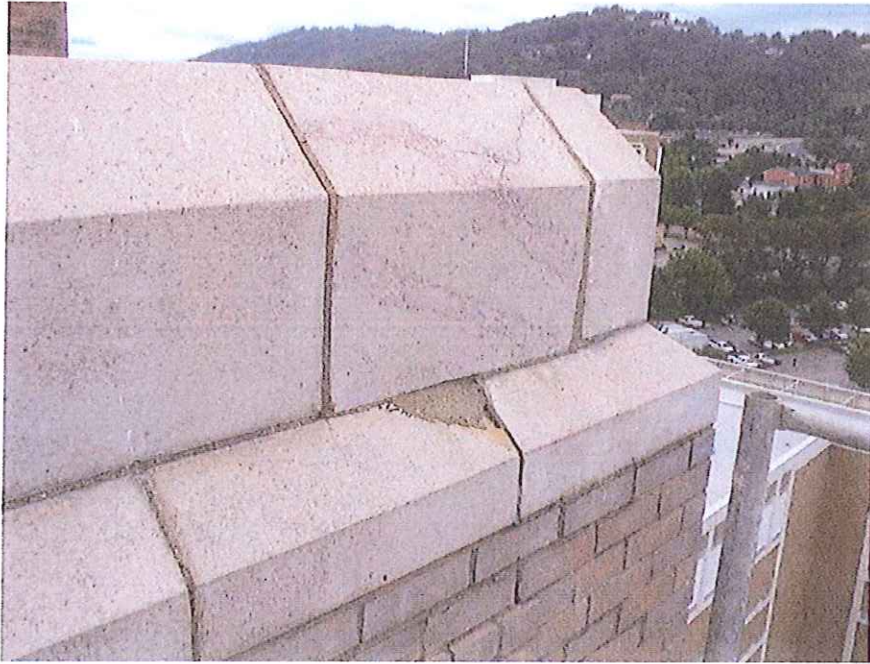
13. A section of the terra cotta coping at the seventh floor level that was previously repaired. The upper repair was made using an epoxy material and the lower repair was made using mortar. Both of the repairs are failing.

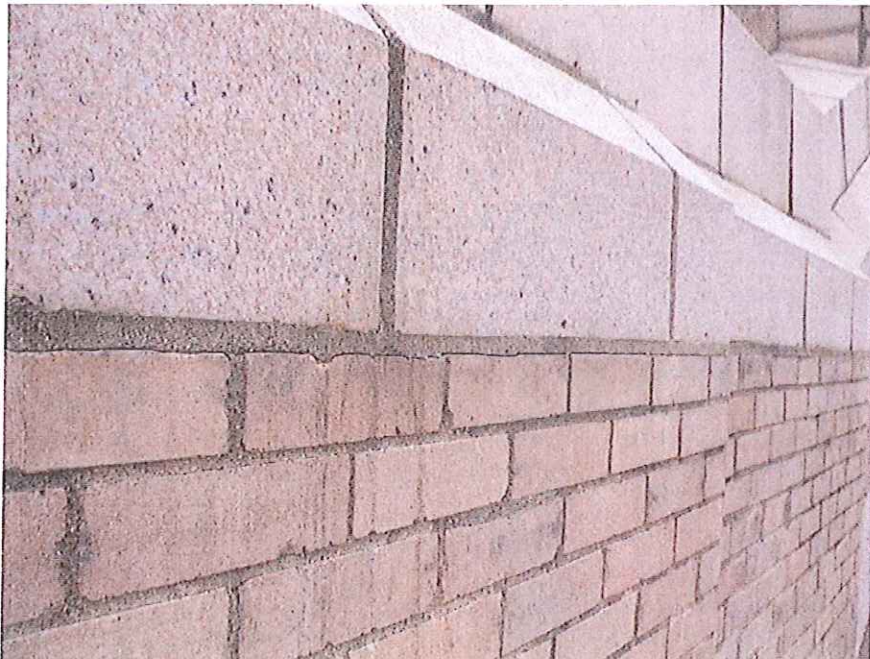
14. The mortar joint below the terra cotta coping is cracked. Water running off the terra cotta can be pulled into the joint due to capillary action.

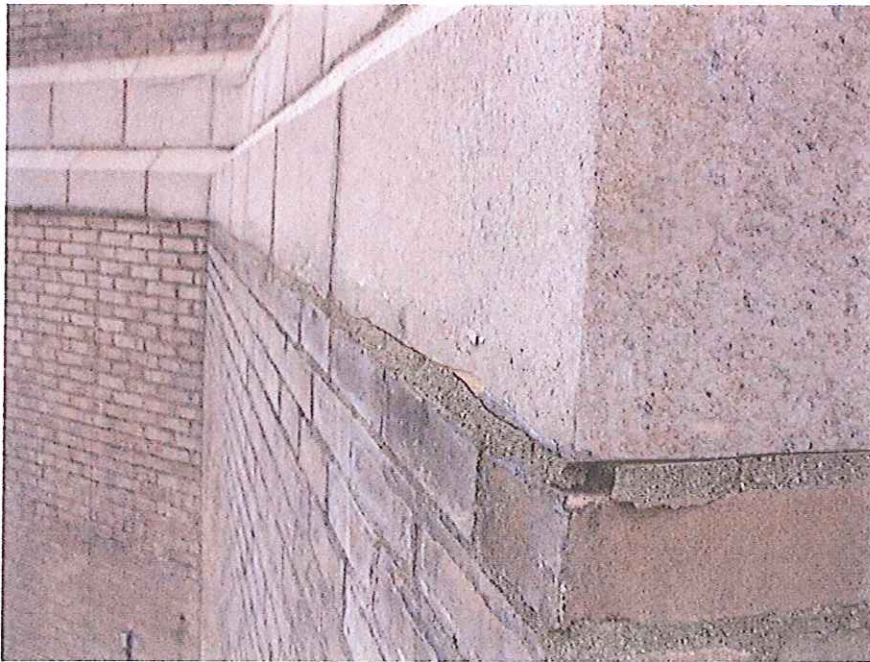
15. Cracking in the mortar joint below the terra cotta and some mortar that is falling out of the joint.

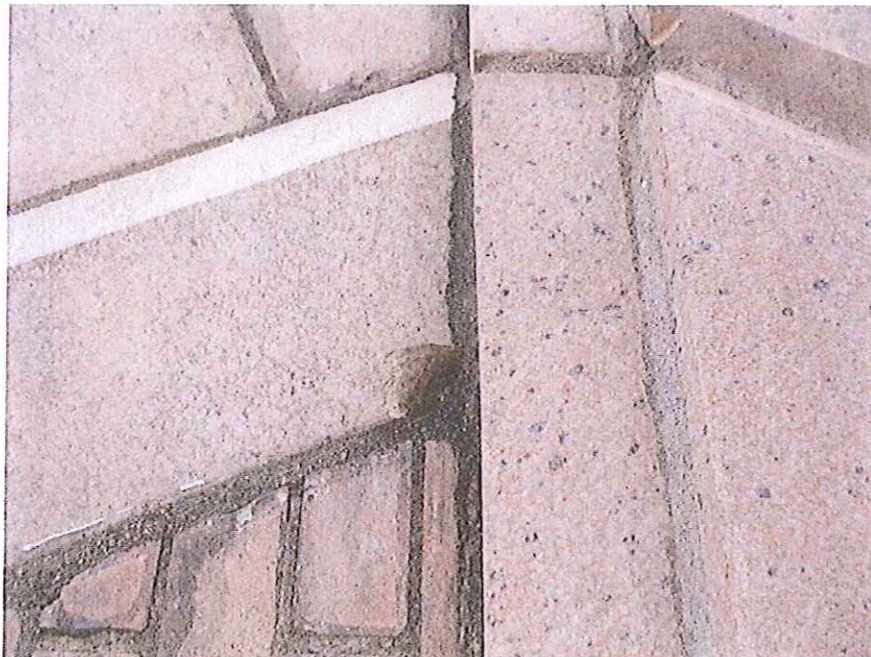
16. A section of chipped terra cotta showing traces of water seepage from above.

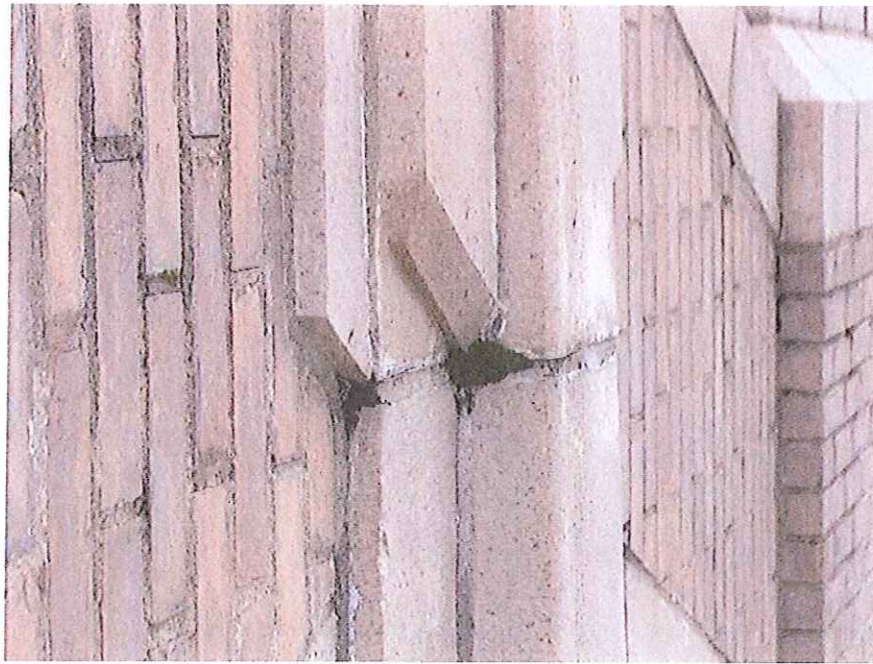
17. Moss growth in the mortar joints in the terra cotta.

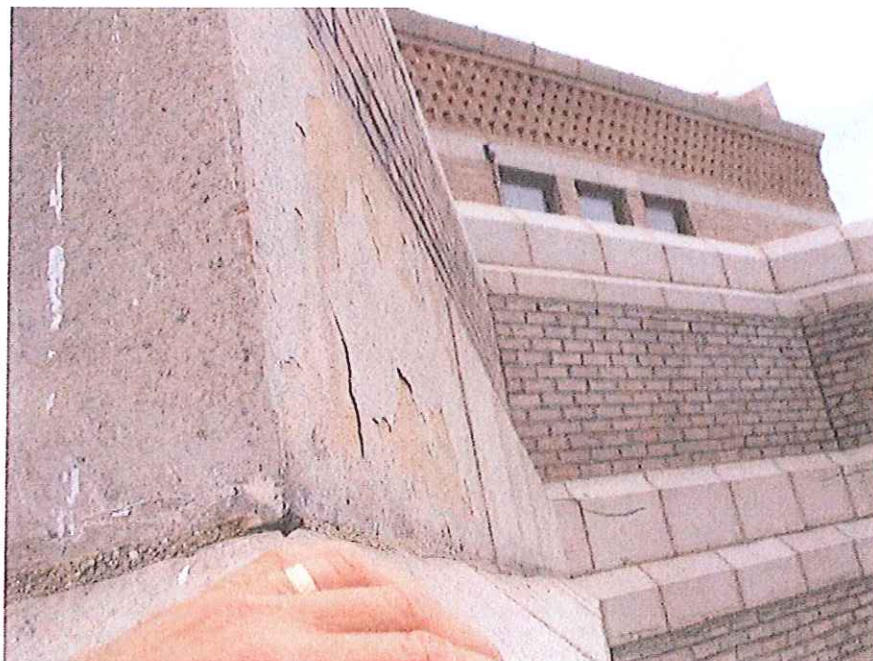
18. A view of some of the terra cotta showing spalling of the glazing, cracks in the terra cotta and missing mortar in the joints.

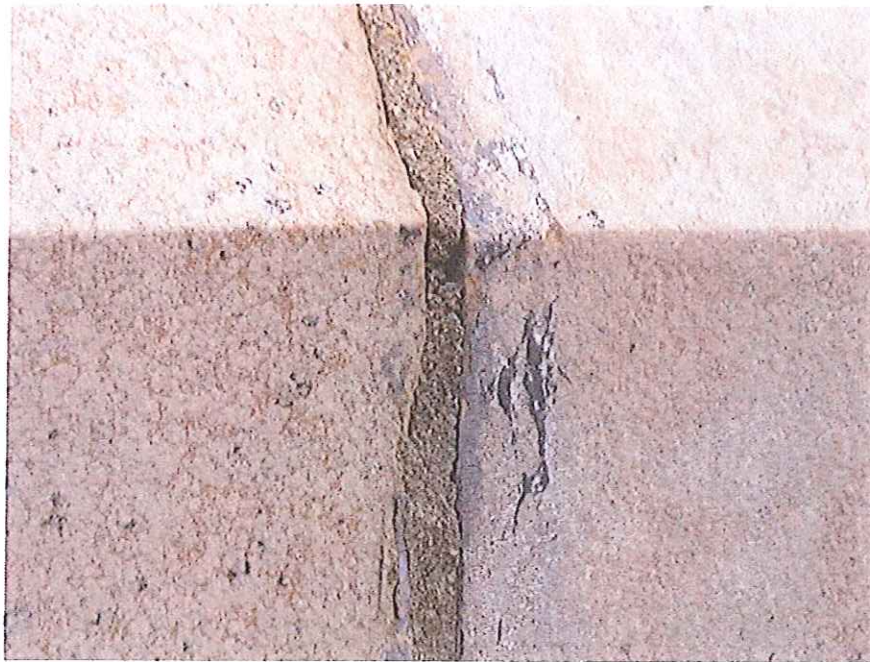
19. A typical mortar joint between the terra cotta coping showing separation between the mortar and the terra cotta units. These cracks allow water to penetrate into the top of the wall.

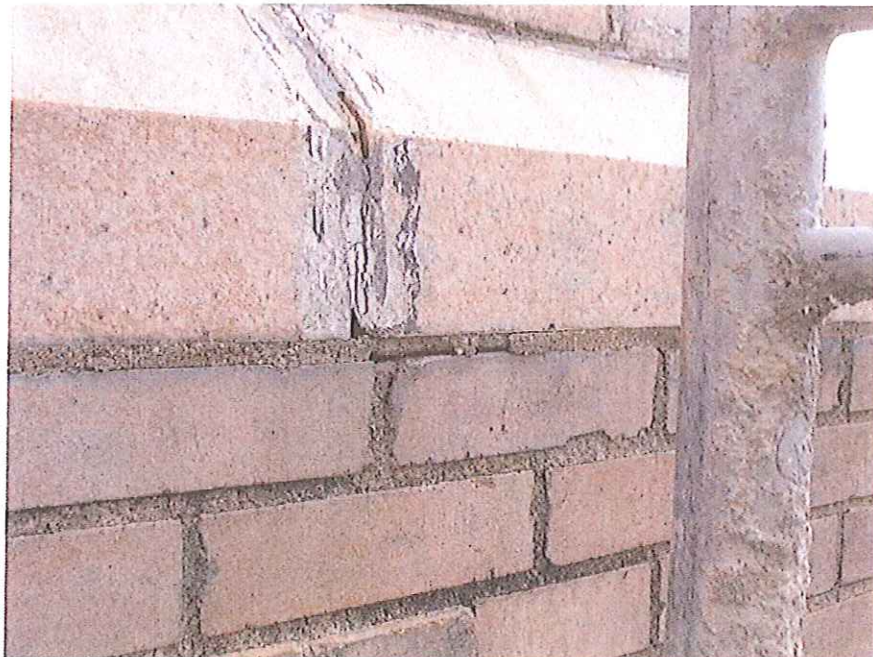
20. Another location where mortar is cracked or missing in the terra cotta and brick construction.

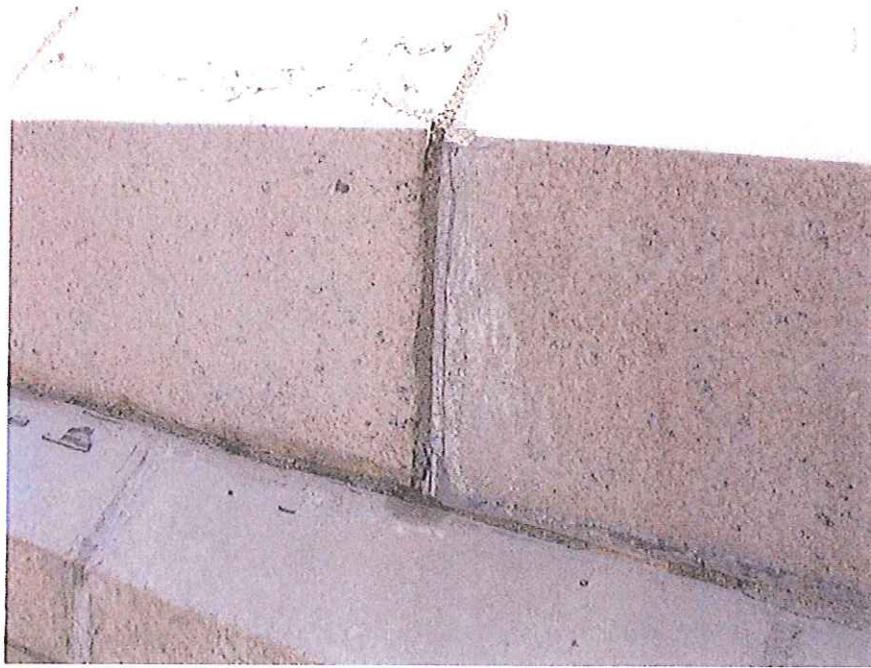
21. An area of the terra cotta coping after rain the previous day. Failing repairs in the terra cotta can be seen as well as water weeping out of the mortar joints.

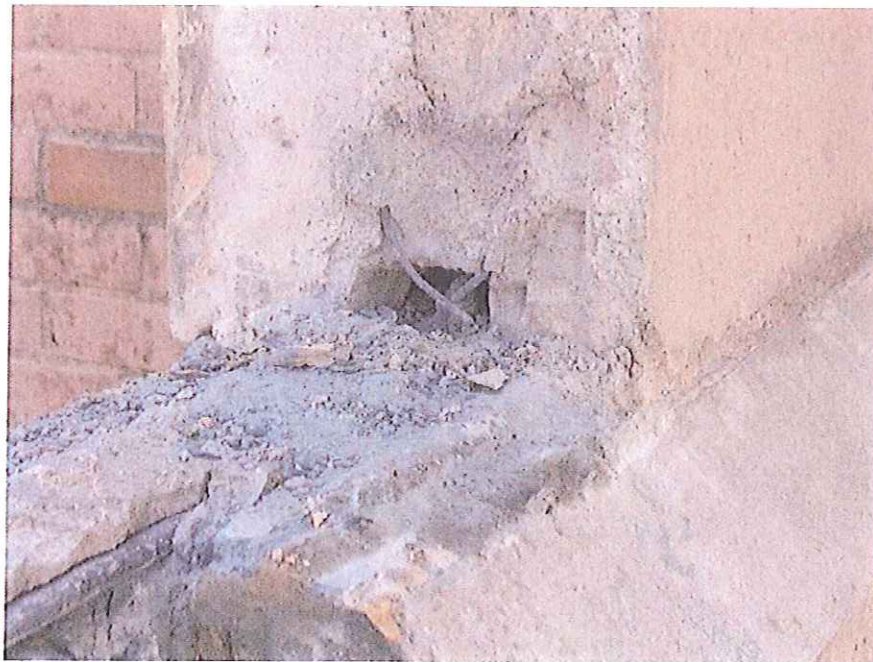
22. A view of the terra cotta anchorage on the north wall at the northeast corner of the building. The anchor wire at this location wraps into the mortar joint, but does not wrap around the anchor bar below. Note that the mortar is wet at this location. Water was discovered as the terra cotta unit was removed.

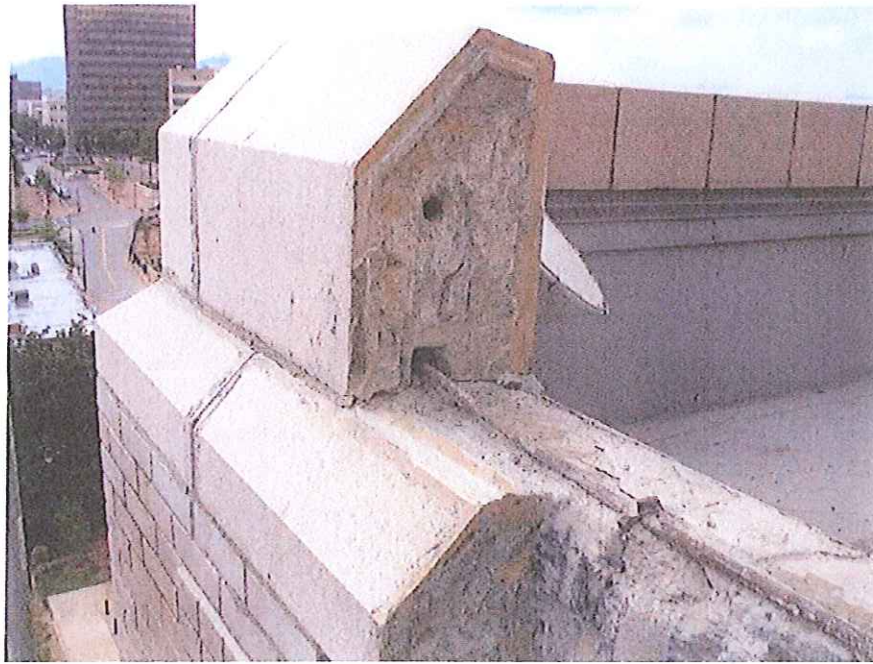
23. A section of terra cotta was removed at the northwest corner of the seventh floor. This photo shows the anchor bar running below the terra cotta coping and the anchors securing it into the wall below.

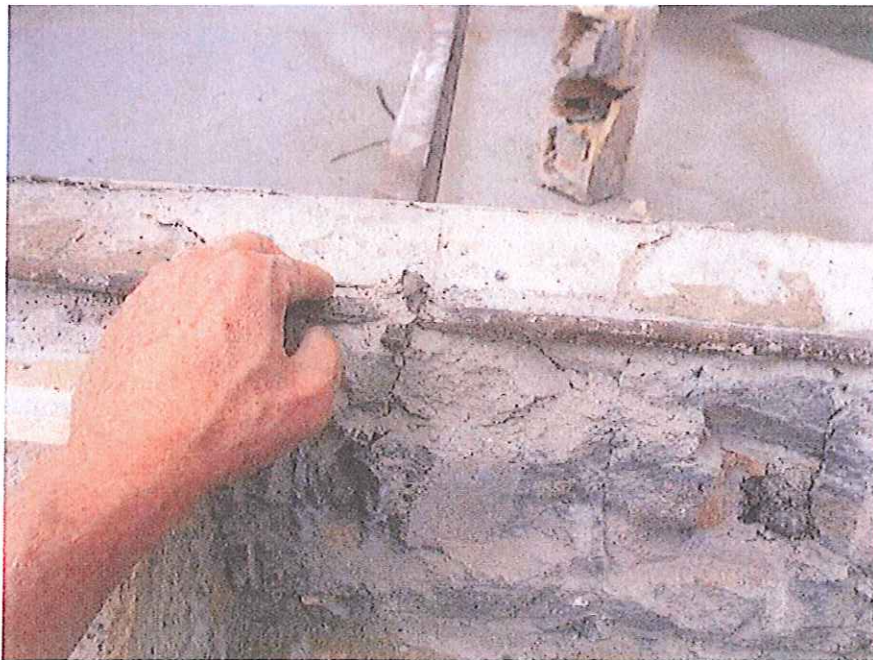
24. One of the anchors securing the anchor bar in place. There is severe corrosion of the anchor bar at this location.

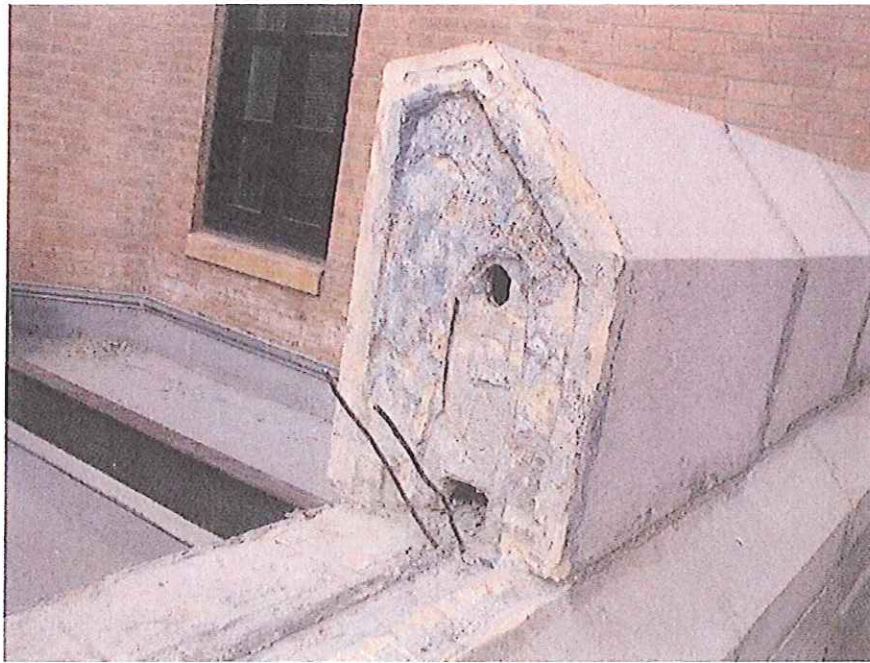
25. A view of what is believe to be a bronze anchor wire used to secure the terra cotta coping to the continuous anchor bar. The wire wraps around the anchor bar and extends into the mortar joint between the terra cotta units.

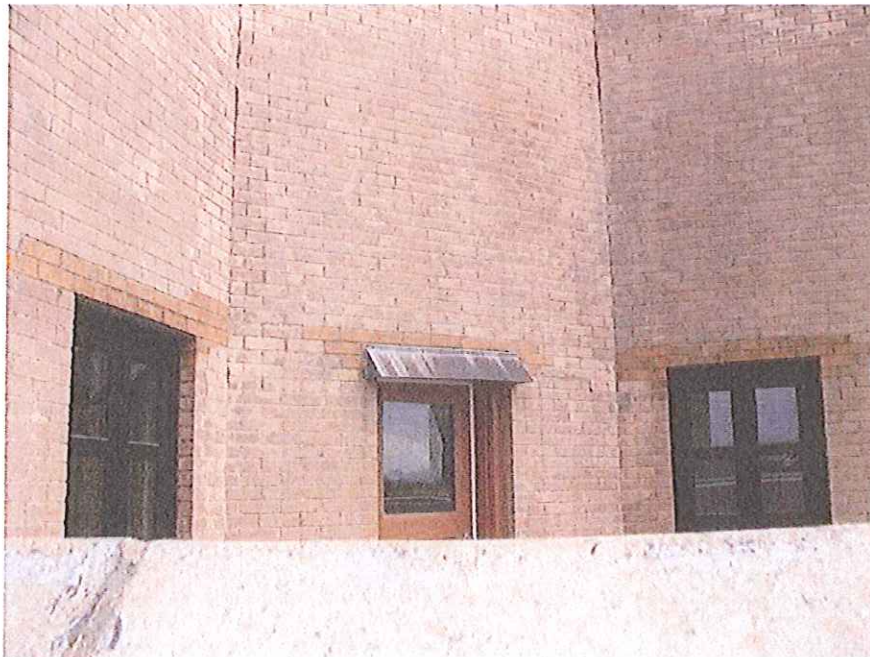
26. Some of the brick that was previously replaced above the window and door openings at the stepped roof level at the seventh floor. No flashing or weeps were noted in the brick that was replaced at this location.

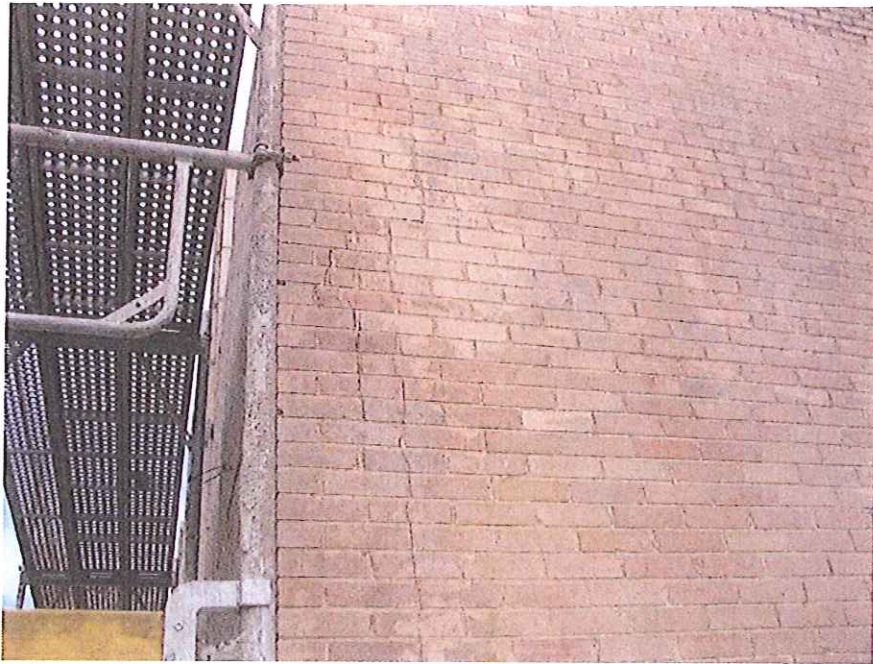
27. A vertical crack in the rising wall at the seventh floor level. At this location, the brick on the outside of the building extends from the second floor upward while the rising wall is supported at the seventh floor level. This creates differential movement in the brick. This condition is typical at all of the rising wall conditions.

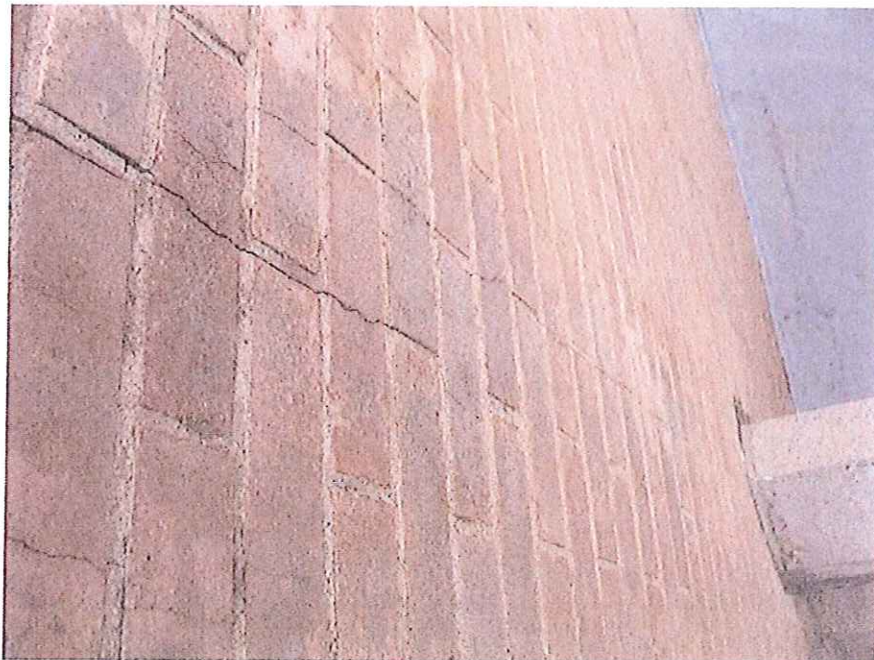
28. Another view of a rising wall condition looking down from the eighth floor to the seventh. Note that the location of the crack in the wall aligns with the location of the parapet below.

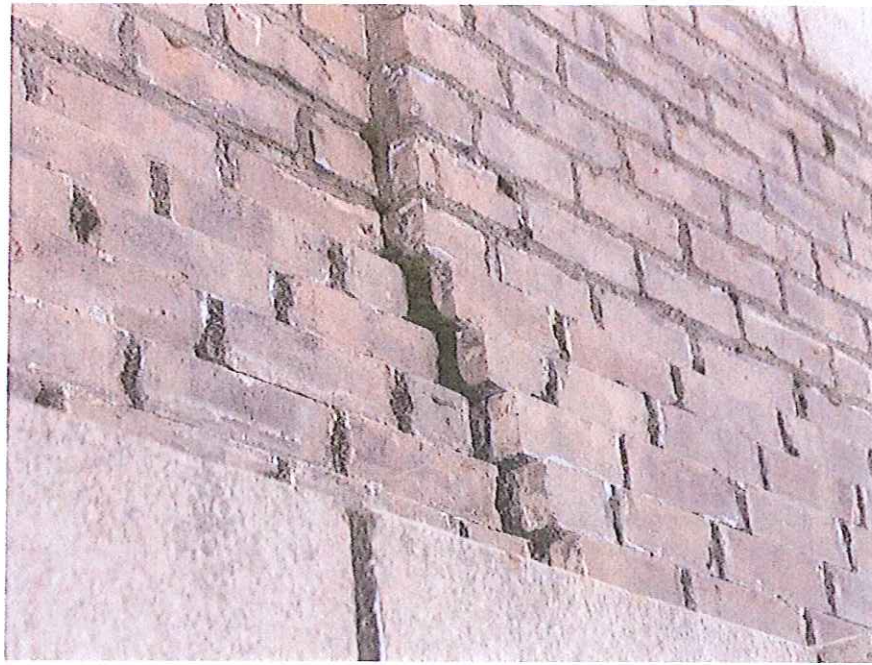
29. A view of some of the brick on the building showing extensive moss growth on the mortar joints. The growth of moss generally requires a damp location with a relatively constant source of water.

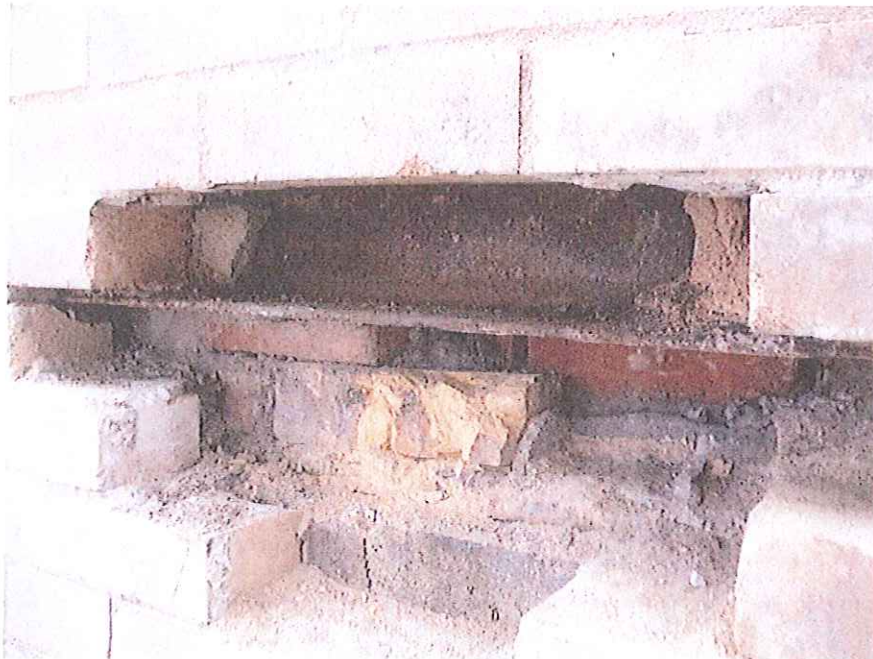
30. One of the locations where brick was removed to view the condition of the structure behind the brick veneer. The shelf angle has a significant amount of corrosion present. There is no flashing at the shelf angle and no weeps were found in the brick.

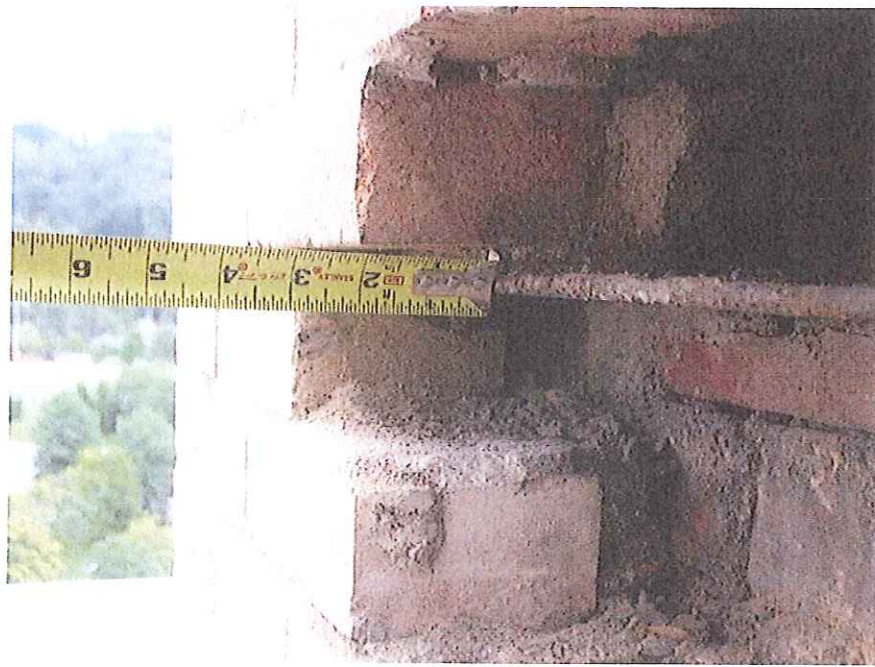
31. The shelf angle at this location supports approximately one half of the width of the brick. Standard practice is for the brick to bear at least two-thirds the width of the brick onto the shelf angle. Also, there is no expansion joint in the brick at the shelf angle.

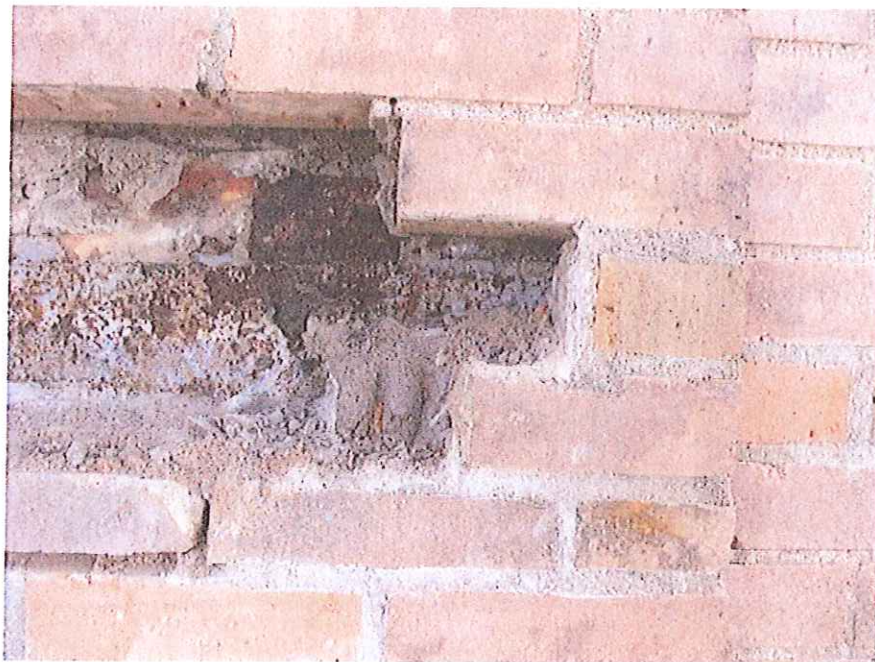
32. Another inspection port in the brick showing corrosion of the shelf angle, no flashing and no expansion joint in the brick at the shelf angle. This location was wet when the brick was removed.

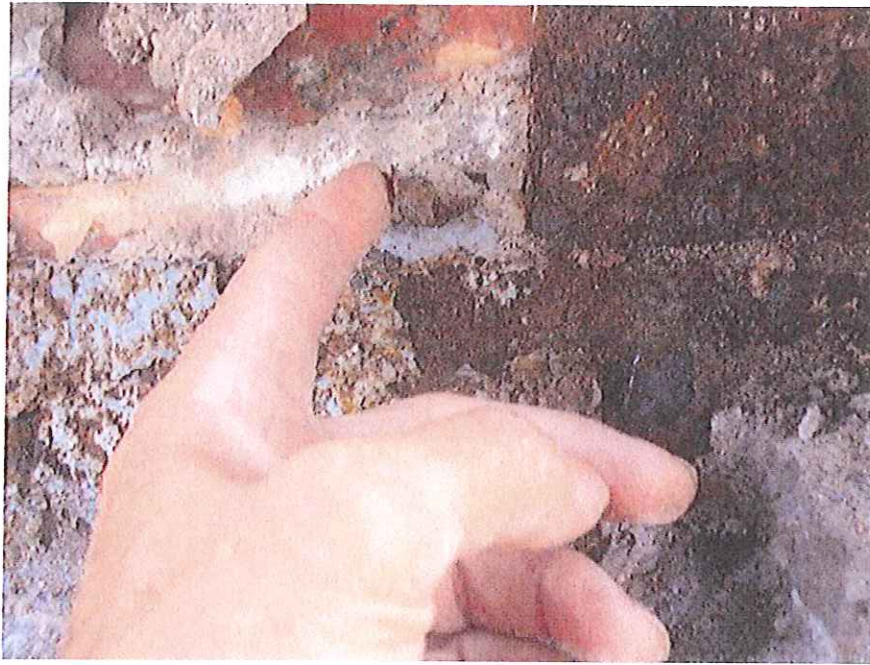
33. The remains of a corroded brick tie found when the brick veneer was removed.

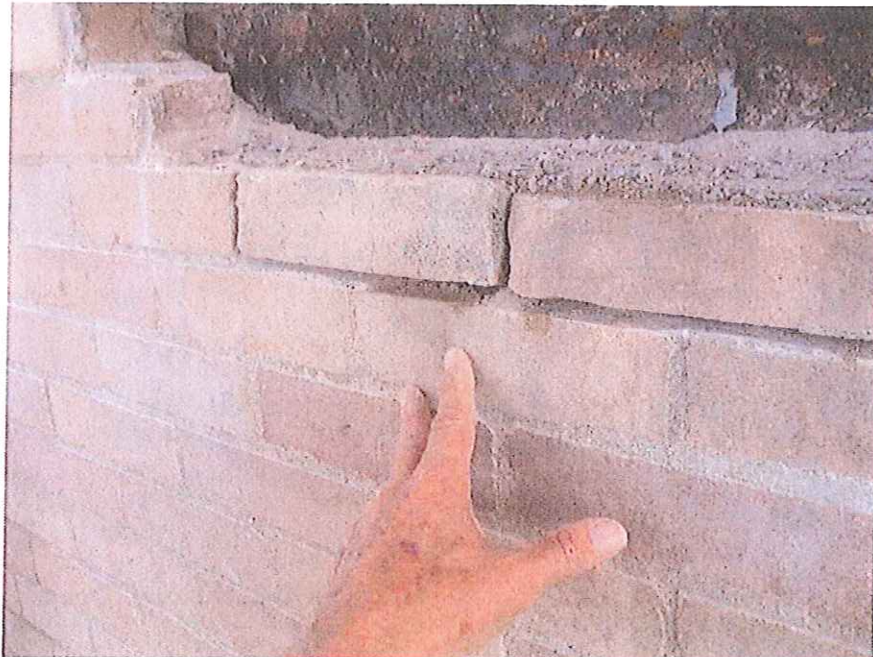
34. Another brick inspection port opened in the brick veneer. Water that had collected on the shelf angle ran out when the brick was removed.

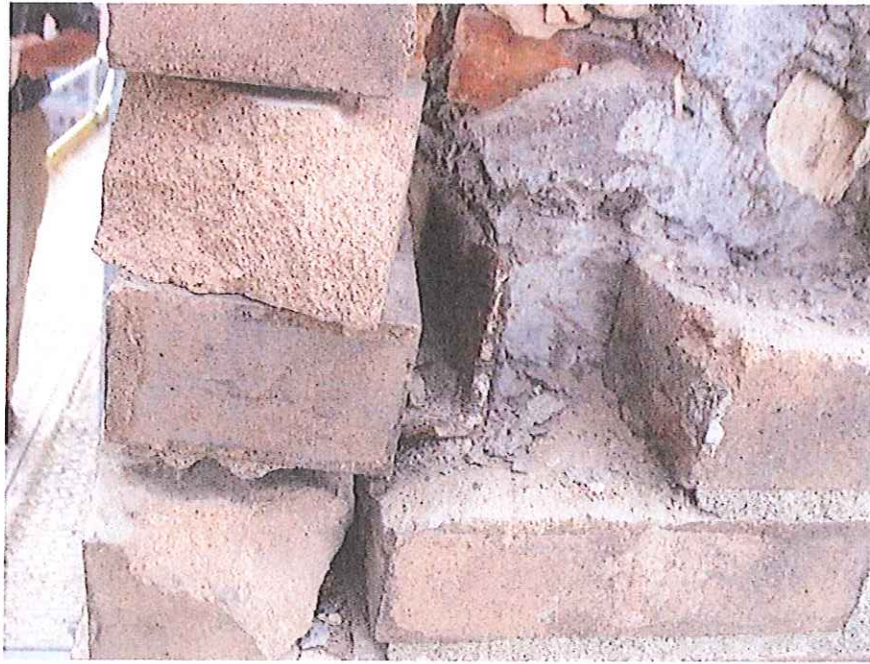
37. The shelf angles in the rising walls stop where the wall turns in onto the inset roof areas.

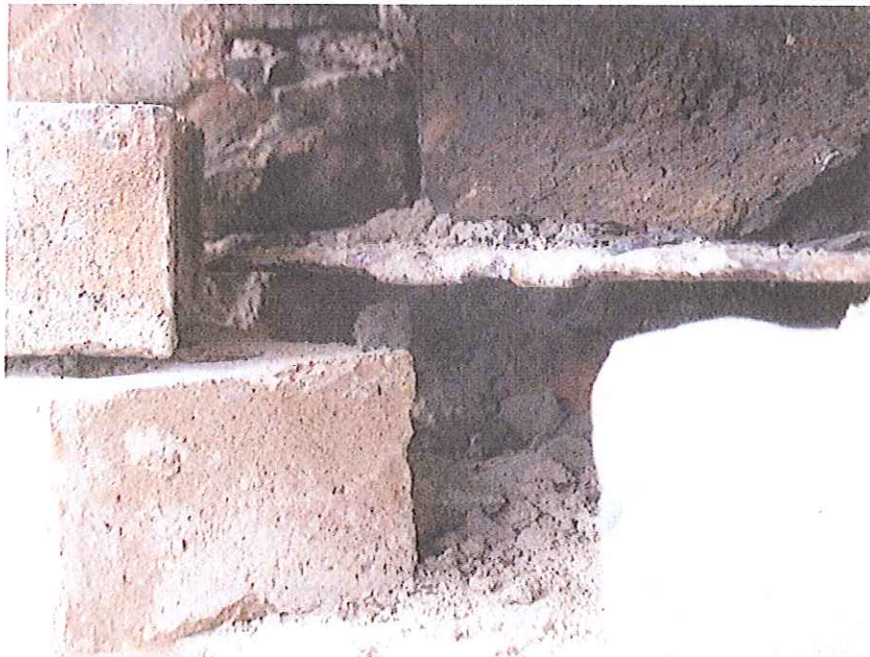
38. An inspection port opened near the southwest corner of the building. The shelf angle is heavily corroded and scaling. The material on the shelf angle is exfoliated steel from the vertical leg of the shelf angle.

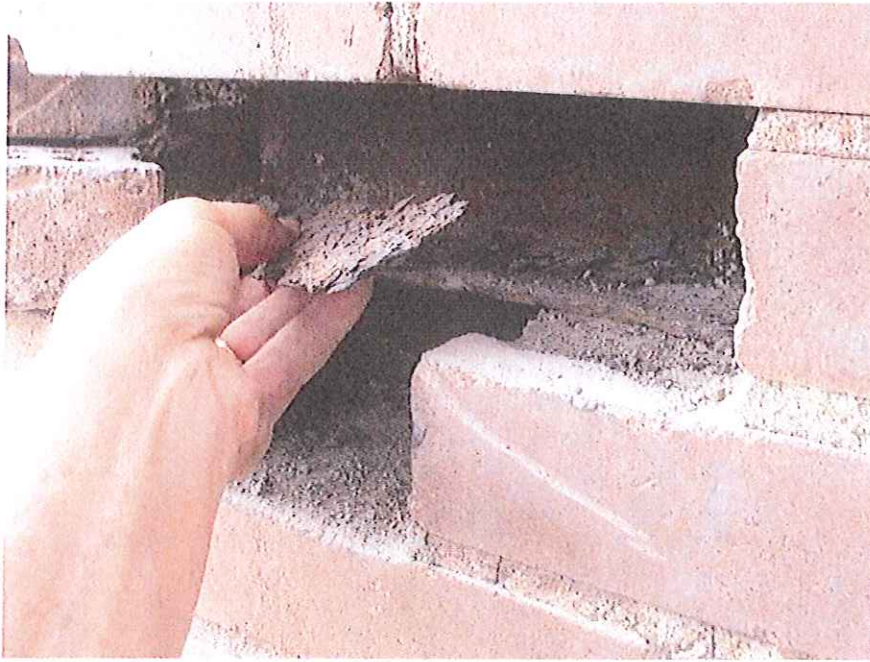
39. An example of severe corrosion of the shelf angles on the building. While the corrosion by-product occupies a much larger volume than the parent metal it comes from, this represents a very serious condition that can adversely affect the stability of the brick veneer.

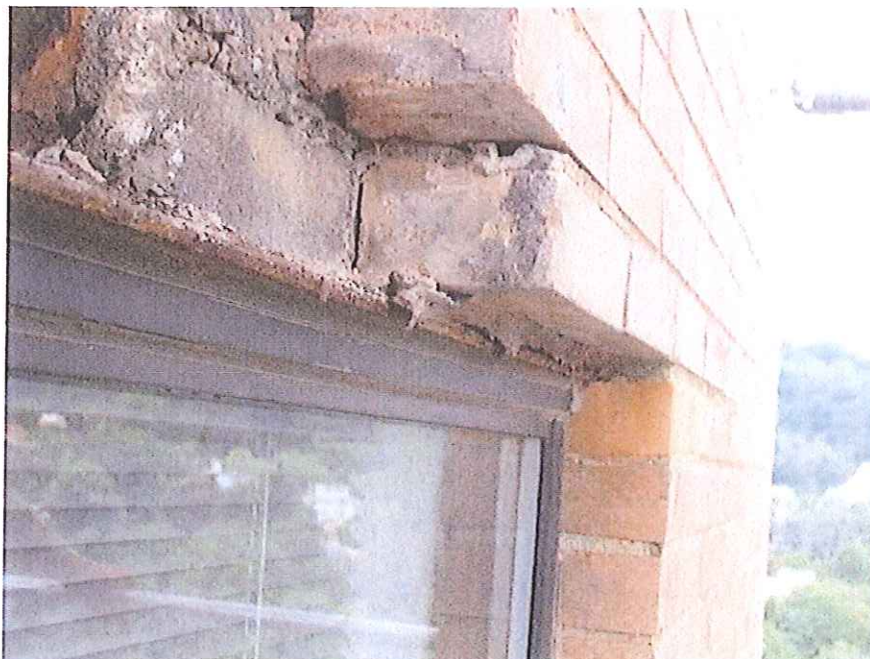
40. The brick at east sixth floor window at the southeast corner of the building is supported on the shelf angle less than 1". It was noted that the brick was previously replaced at this location, and is bowing outward above the window. No brick ties, flashing or weeps were found. It is our opinion that the brick is very unstable at this location.

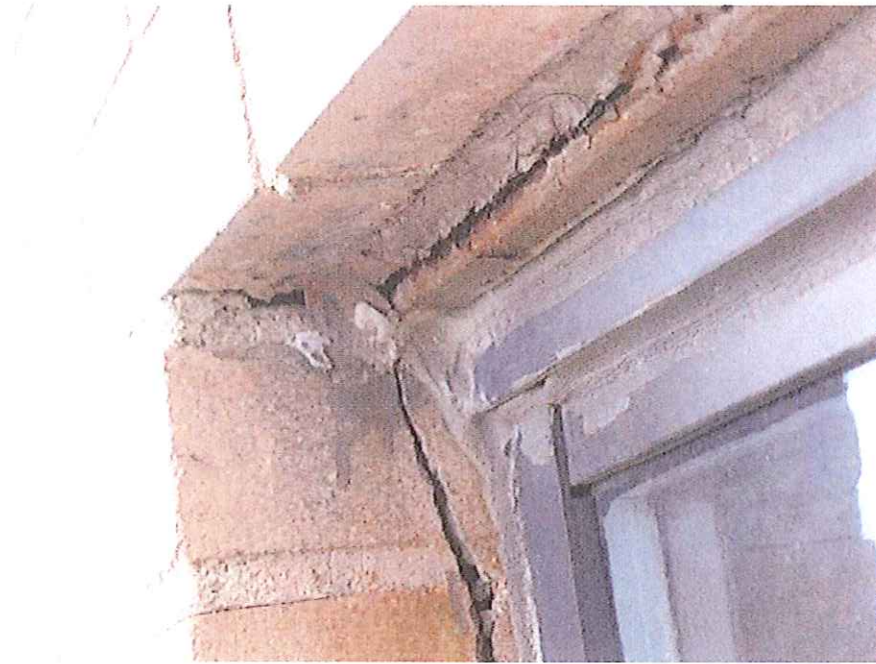
41. Another window opening on the south wall of the building where the brick is not adequately supported by the steel shelf angle.

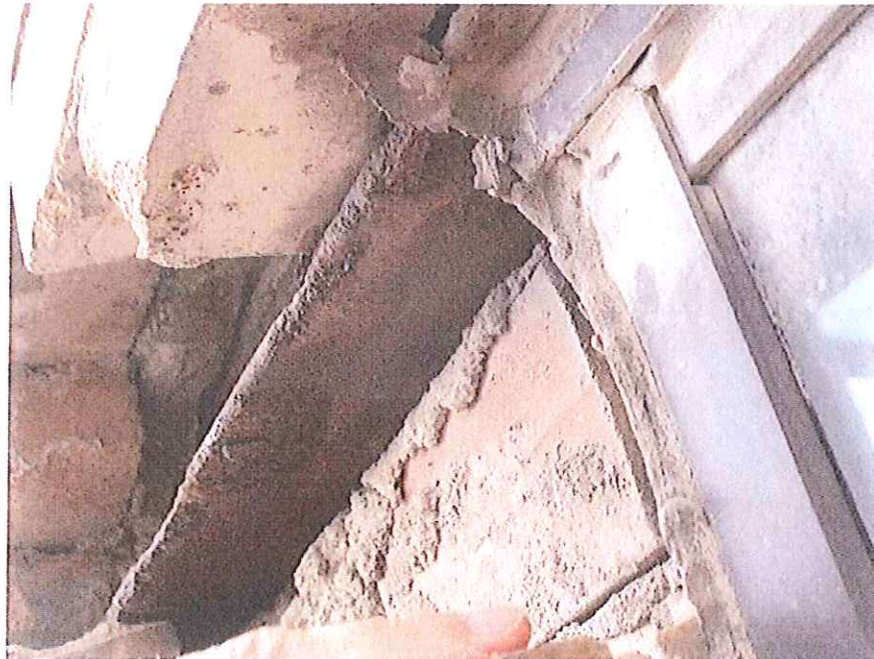
42. A view of the same window opening shown in photo 41. The brick is barely supported on the shelf angle.
